## Identification of the Cause of Damage to the Firefighter Ladder

Filip Průša<sup>1</sup>, Vít Jonák<sup>1</sup>, Angelina Strakošová<sup>1</sup>, Karel Doubrava<sup>2</sup>, Miroslav Španiel<sup>2</sup>, Václav Vystrčil<sup>3</sup>, Dalibor Vojtěch<sup>1</sup>

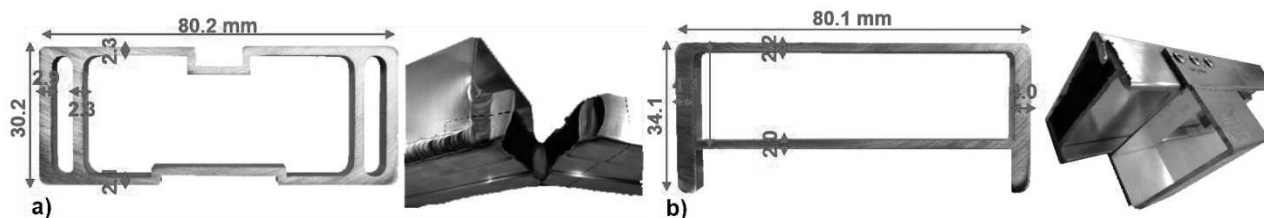
Two different types of extendable firefighter ladders were used to investigate the influence of different beam profile and different guide mounting technique (welded, riveted) on the mechanical properties (Fig. 1).

**Fig. 1** Complex overview of both the tested ladders showing: a) brand new piece with complex profile and welded guides (ladder no. 1); b) 5-year old ladder with guides attached via rivets (ladder no. 2)

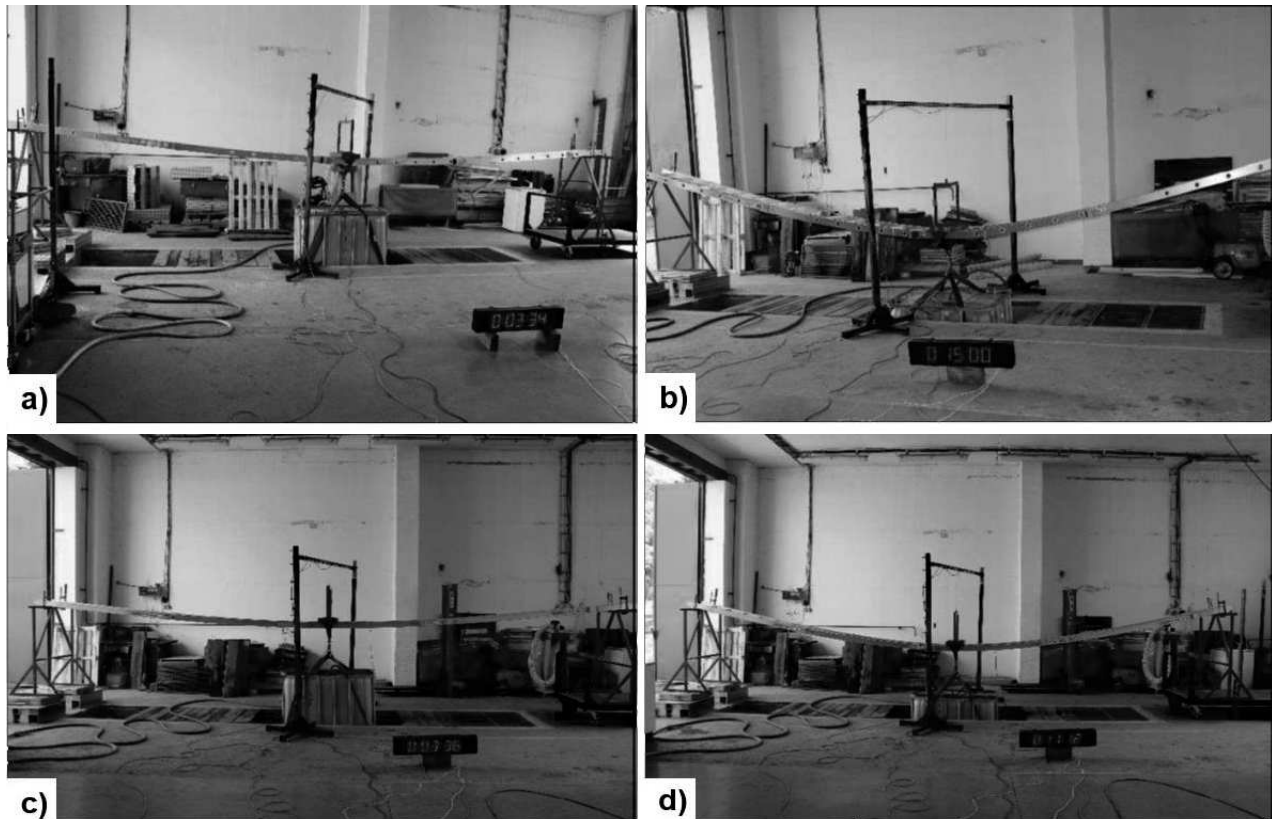
Both the ladders were tested accordingly to the prescriptions stated in the ČSN EN ISO 1147 as is shown in Fig. 3a,c. The water bags were gradually filled with water and the ladder sag was measured during the filling. It was found that the brand new ladder

no. 1 exhibited 90 cm deep sag 33 s before breaking (see Fig. 3b). The test was repeated on the second identical ladder reaching highly comparable results achieving a maximum load of 366 and 365 kg. On the other hand, the 5-year old ladder no. 2, with a much simpler beam profile, showed smaller sag withstanding a significantly higher load of 426 kg (Fig. 3d).

**Fig. 3** The experimental setup used for destructive testing of the extendable firefighter ladders showing: a,b) ladder no. 1 at different stages of the test; c,d) ladder no. 2 at different stages of the test

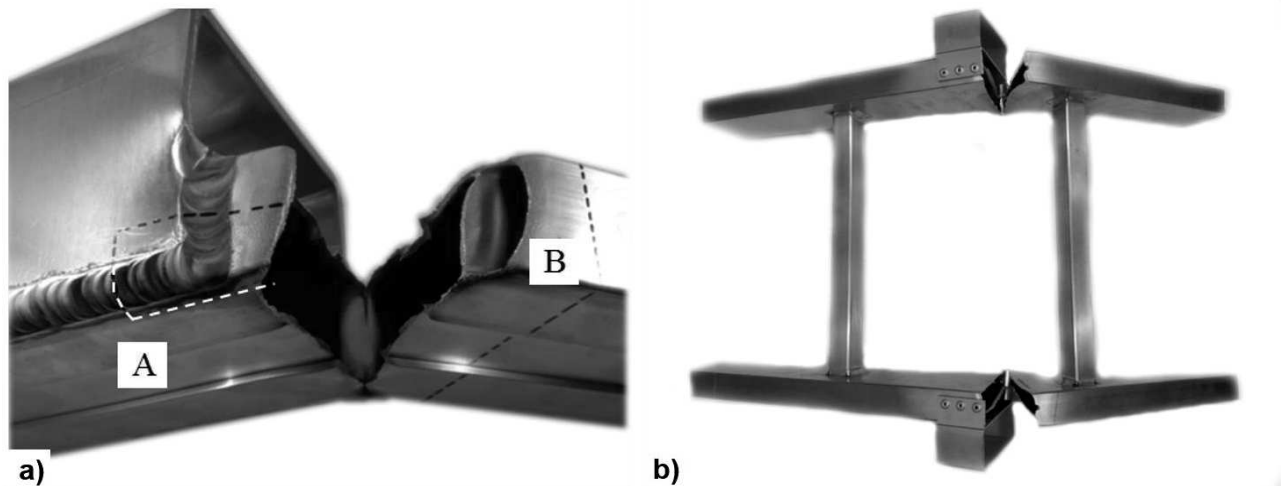
The ladders were cut to extract the area around the cracks as is shown in detail in Fig. 4. One can see, that the ladder no. 1 initiated the crack approximately 10 mm from the weld (see Fig. 4a). This corresponds with the area which was thermally affected due to the welding of the guides on beams. On the other hand, the ladder no. 2 cracked in the closest proximity of the riveted guide leaving the rivets on its place. Considering the experimental setup, the maxima of shear force could be expected to form right on the edge of the mounting guide which corresponds with the result shown in the case of ladder no. 2. However, both the tested ladders no. 1 showed initiation of the crack 10 mm from the weld bead edge pointing on a highly localized change in mechanical properties in this area due to thermally-related effects including grain, precipitates and secondary phase coarsening.

**Fig. 4** A detailed insight on the fractured areas of: a) ladder no. 1 with areas used for further examination); b) ladder no. 2

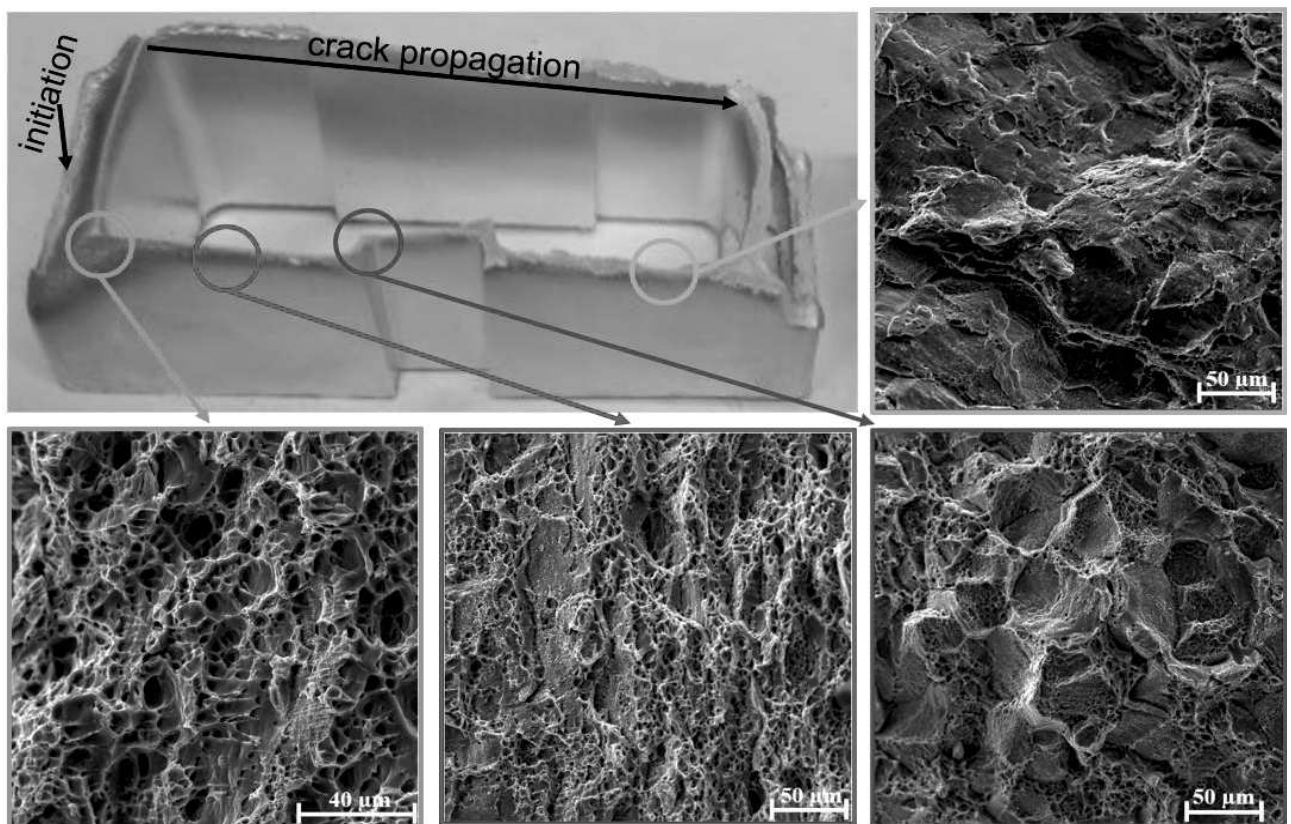
much better results compared to that observed. The fracture surface was extracted from the broken piece as is marked in Fig. 4a (area B) to be investigated using SEM. On the left side (Fig. 5), the initiation of the crack occurred which was confirmed by a presence of equiaxed dimples corresponding to a plastic deformation along this area. Moreover, some dimples also show in its centre a presence of secondary intermetallic particles, which were identified as Al(Fe,Si)Mn. As the crack continuously growth, the morphology of the fracture surface changes slightly showing also a presence of cleavage steps suggesting an increasing ratio of brittle behaviour within the material. This corresponds with the speed of the crack propagation and is confirmed by a steady increase in the content of facets. The rest of the material shows strictly a brittle morphology of the fracture surface without any traces of dimples corresponding to a fast termination of the crack growth.

**Fig. 5** SEM micrographs of fracture morphology taken on several places on the beam showing changing morphology from ductile to brittle behaviour

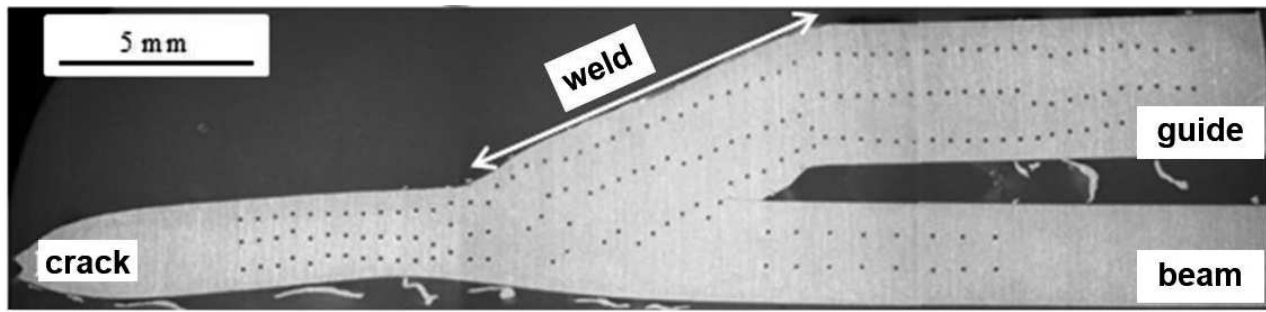
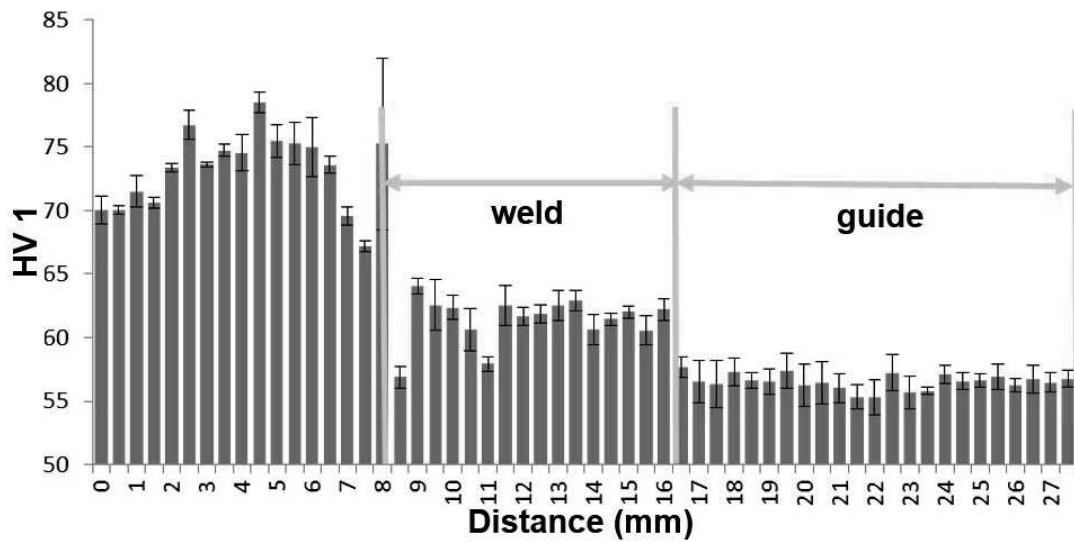
Besides, the weld was also investigated for microstructure and hardness distribution along the longitudinal axis of the tested beam as it is marked in Fig. 4a (area A). It was found, that the hardness distribution was highly scattered considering the thermally induced effects during welding of the guide (Fig. 6). The lowest hardness was reached in the guide reaching an average hardness of approximately 58 HV 1. Compared, the weld itself reached slightly higher hardness of approximately 62 HV 1, although the results were showing higher heterogeneity. While continuing from

the weld towards the crack site resulted in a sharp hardness increase up to 75 HV 1 showing also scattered values. This was caused either by the heterogeneity of the microstructure due to temperature-related effects (grain coarsening, the formation of metastable phases, grain size heterogeneity with strong orientation along the thermal gradient etc.) as well due to a deformation strengthening caused during the test. Also, the deformation strengthening contributed to the overall high heterogeneity of the hardness distribution.

Fig. 6 The hardness HV 1 distribution in the broken ladder along the beam, weld and guide

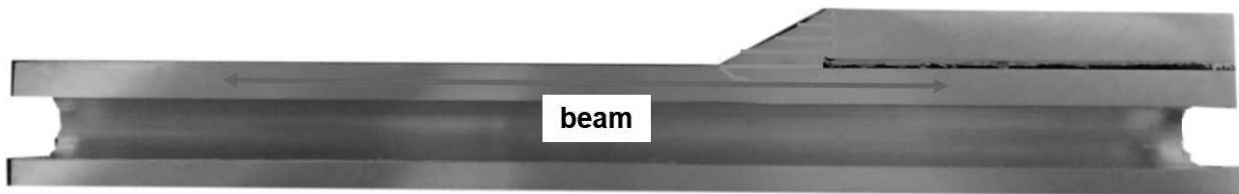
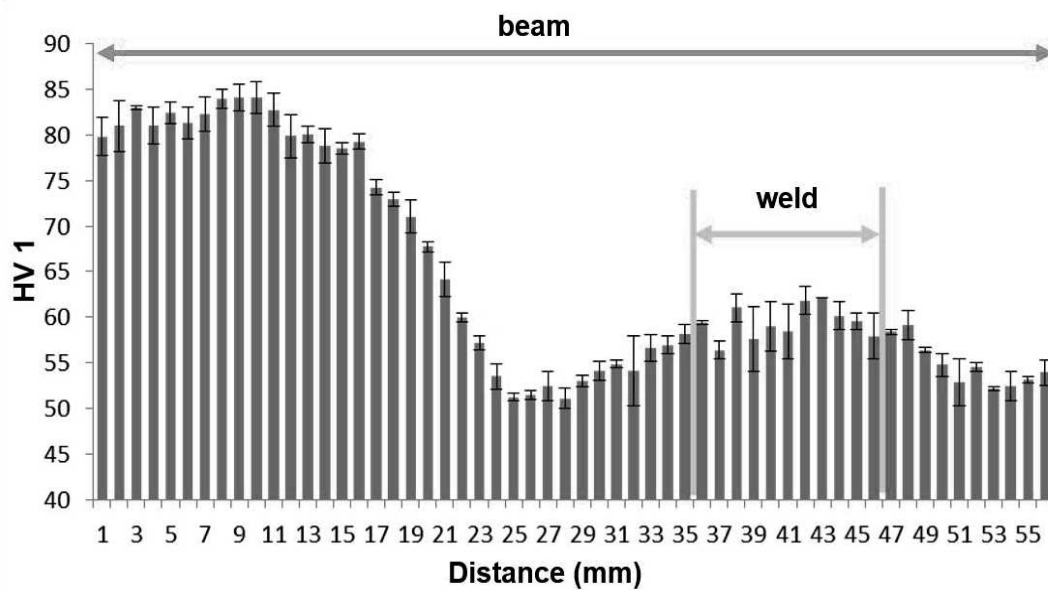
Fig. 7 The hardness HV 1 distribution across the beam showing a heat-affected area nearby the weld

Thus, the same area was examined on the non-tested part of the ladder to provide complex information about the hardness distributions (Fig. 7). This test was done to determine the hardness profile of the beam since the crack in all the tests initiated and propagated exclusively only throughout the beam. As is shown in Fig. 7, the hardness of the beam was reaching approximately 82 HV 1, which is in good accordance with our previous investigations that proved the beam having a hardness of approximately 78 HBW 2.5/62.5/10 [1]. One can also see, that with the increasing distance from the weld itself, the hardness decreases suggesting that the heat-affected zone was wider than previously thought.

Closer to the weld, we observed a steep hardness decrease starting approximately 19 mm from the weld bead edge. This decrease reaches its minima of 52 HV 1 in a 10 mm distance of the weld edge. The observed minimum corresponds to the place of the crack initiation and therefore, the main cause of the significantly lower performance of this ladder is attributed to the thermally affected area of the beam. Since the hardness value can be used as a certain prediction to other properties, it can be assumed that the tensile properties of the beam also decreased significantly. This allows initiating of a crack and its further growth decreasing the active cross-section of the ladder and quick breakage.

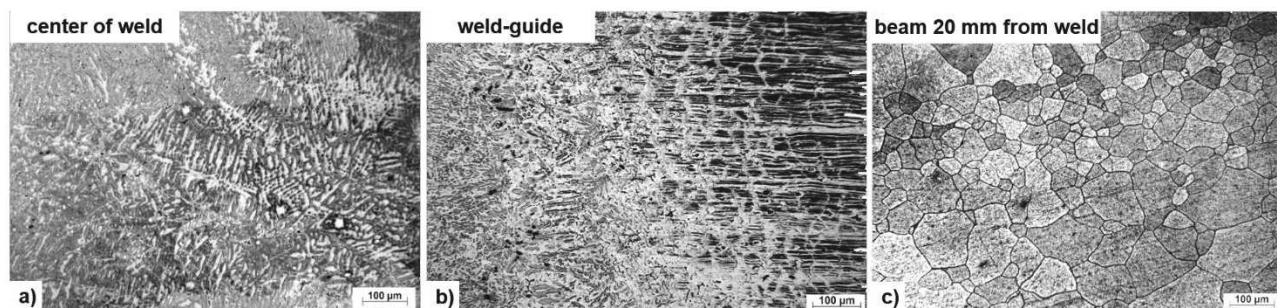
*Fig. 8* OM micrographs were taken in: a) the centre of the weld; b) in the area between the weld and guide; c) the beam 20 mm away from the weld

zone, which exhibited much lower hardness than the rest of the beam, also corresponded with the crack initiation. Thus, the different areas around the weld bead were investigated by the means of OM as is shown in Fig. 8. The centre of the weld (Fig. 8a) showed a variety of different structures composed of dendritic-like structures which form due to low cooling rates which are typically achieved in the middle of the central parts of the weld. On the other hand, the interface between weld and guide (Fig. 8b) showed on the side adjacent to the weld a presence of fine-grained phases which were substituted by an elongated needle-like phase-oriented in the direction of heat dissipation. Further, towards the right side, a visible texture with grains oriented in the forming direction can be seen. As a comparison, the microstructure of the beam 20 mm away from the weld was also observed showing presence of recrystallized equiaxed grains which are present in the extruded material. From this point of view, the guide was welded in the as-received state while the beam has undergone a hot-extrusion and artificial ageing which resulted in a formation of equiaxed grains and finely dispersed particles of Al(Fe,Si)Mn phases as well as by the presence of nanocrystalline Mg<sub>2</sub>Si precipitates which are also reported by others. The presence of these microstructural constituents was confirmed by detailed SEM and TEM investigations, although are not present here.
