## Ultrasonic-Based Active Thermography for Determining Depth Detection Limits in Onyx Composites

**This paper examines the detection of internal defects in composite specimens composed of Onyx, a material featuring a nylon matrix reinforced with chopped carbon fibers. Artificial defects, in the form of flat-bottom holes of various geometries, were intentionally introduced during the additive manufacturing process. The primary objective is to determine the depth detection capabilities of ultrasound by varying the excitation frequency and determining whether these defects remain identifiable at different subsurface levels. Ultrasonic lock-in thermography is utilized to excite specimens. As the frequency is modified, the depth of wave propagation also changes, a phenomenon well established in homogeneous materials. However, the heterogeneous nature of Onyx introduces complexities into wave propagation. The recorded thermographic data are processed in MATLAB to calculate contrast ratio values, enabling a quantitative comparison of defect detectability for different defect geometries.**

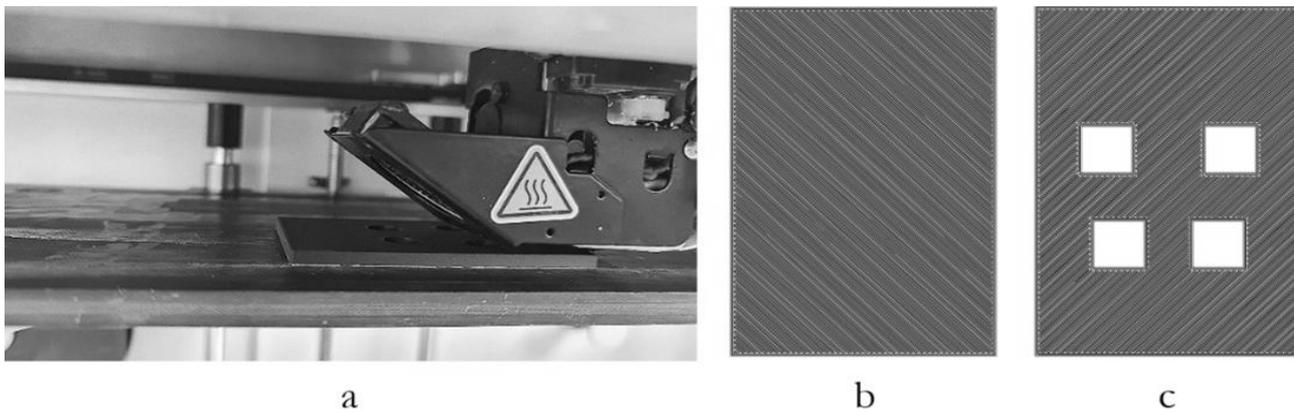
**Fig. 1** a) FDM printing of the specimen with circular flat-bottom holes; b) Bottom layer of the specimen; c) Top layer of the specimen with square flat-bottom holes

The specimens used in this study were fabricated using a Markforged Mark Two 3D printer, employing the Fused Deposition Modeling (FDM) technique. In this process, the material is deposited layer by layer through a heated nozzle.

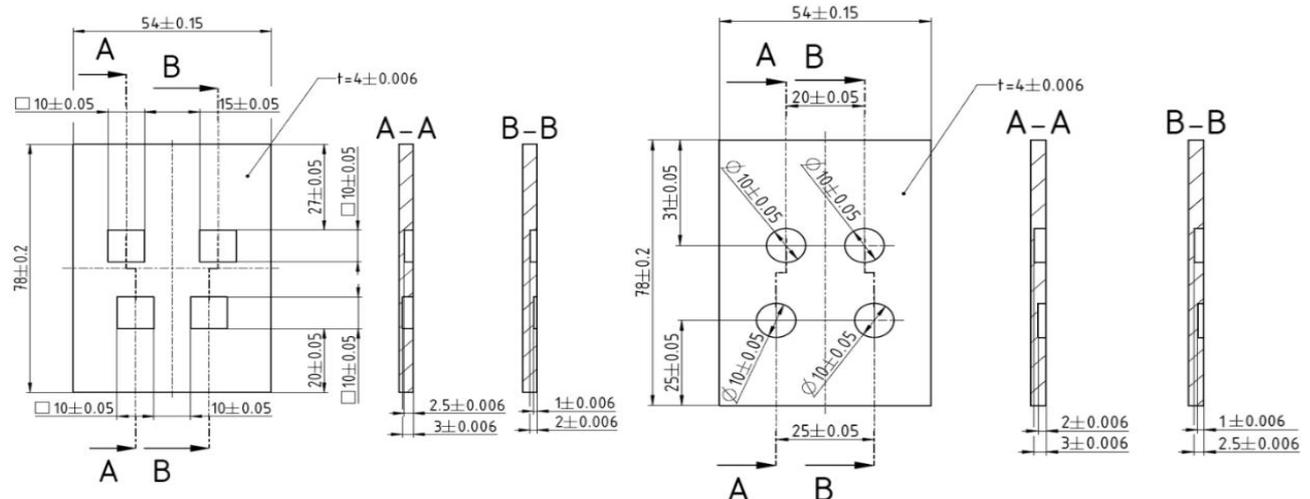
**Fig. 3** Technical drawings of the Onyx specimens showing dimensions and positions of artificially introduced flat-bottom defects (circular and square)

Each specimen contained four flat-bottom defects located at depths of 1 mm, 1.5 mm, 2 mm, and 3 mm beneath the inspected surface. In one specimen, the defects were circular with a radius of 10 mm, whereas in the other specimen, the defects were square-shaped with a side length of 10 mm. Both types of specimens had identical external dimensions of 54 x 78 mm and a uniform thickness of 4 mm.

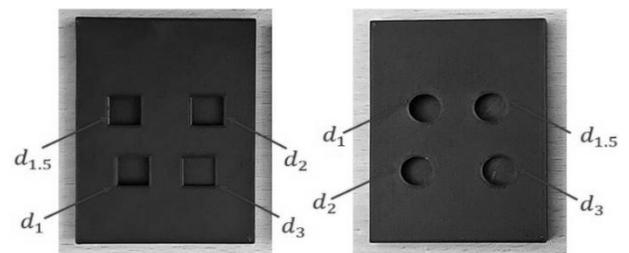
**Fig. 2** Onyx specimens with artificially introduced flat-bottom bores: circular (left) and square (right)

The defects are visible on one side of the specimen, while the opposite side remains intact. This intact surface was used as the inspected side during thermographic measurements. In accordance with the manufacturer's specifications for the Markforged composite printing, dimensional tolerances of  $\pm 0.25\%$  (or  $\pm 250 \mu\text{m}$ ) in the X-Y plane and  $\pm 0.10\%$  (or  $\pm 100 \mu\text{m}$ ) in the Z-direction were applied to all nominal dimensions. These tolerances values were obtained from the official Markforged dimensional accuracy guidelines for the printer used to fabricate the specimens.

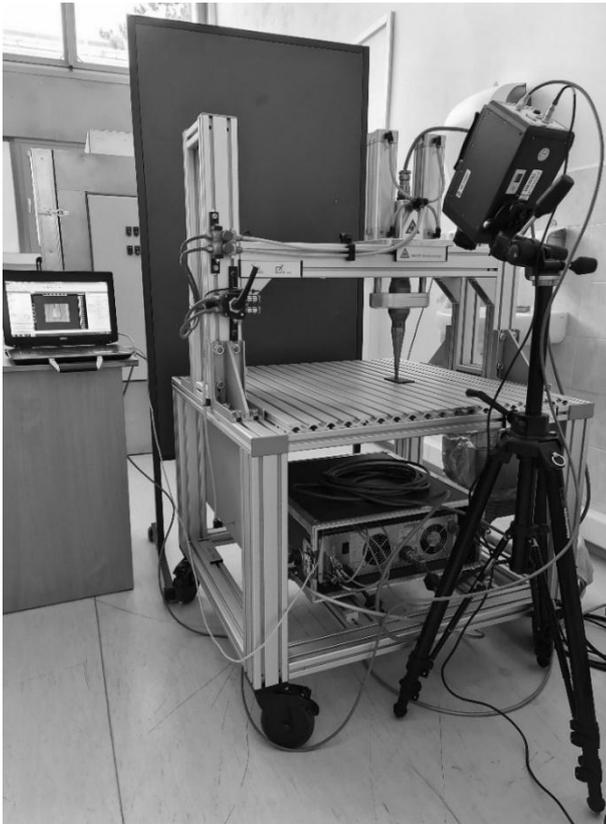
**Fig. 4** Experimental setup for ultrasonic active thermography: overall view of the measurement system with an IR camera connected to a PC and the UTvis system

The experimental setup consisted of a FLIR SC7000 infrared (IR) camera operating within the mid-wave infrared (MWIR) spectral range. This camera is equipped with an actively cooled detector and offers a resolution of 320 x 256 pixels. For this experiment, a 25 mm lens was used without any filters, and the thermal response of the specimen was recorded at a frame rate of 10 Hz. The laboratory temperature was maintained at 23 °C with a relative humidity of approximately 40%.

The sonotrode generates high-frequency ultrasonic waves in the range of 15–25 kHz, which are modulated by a low-frequency lock-in signal  $f_{Lockin}$ . The maximum power output of the UTvis system is 2.2 kW. A specimen's surface without defects was excited, and the response to this excitation was monitored by the IR camera. A thin layer of ultrasound coupling medium (water-based lubricating gel) was applied between the sonotrode and the specimen surface to ensure efficient transmission of ultrasonic energy by eliminating air gaps that would otherwise cause acoustic impedance mismatch and reflection losses.

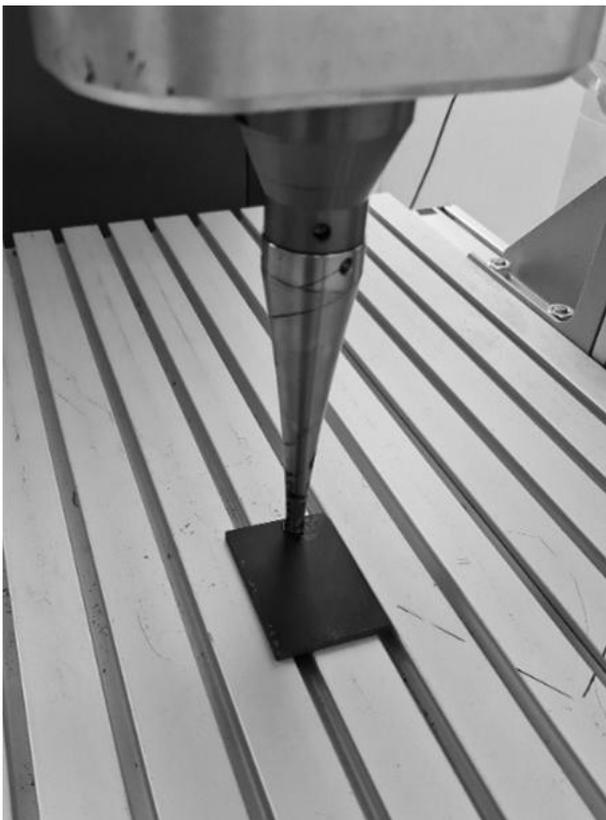
**Fig. 5** Detail of the tested specimen placed under the sonotrode, showing the intact surface

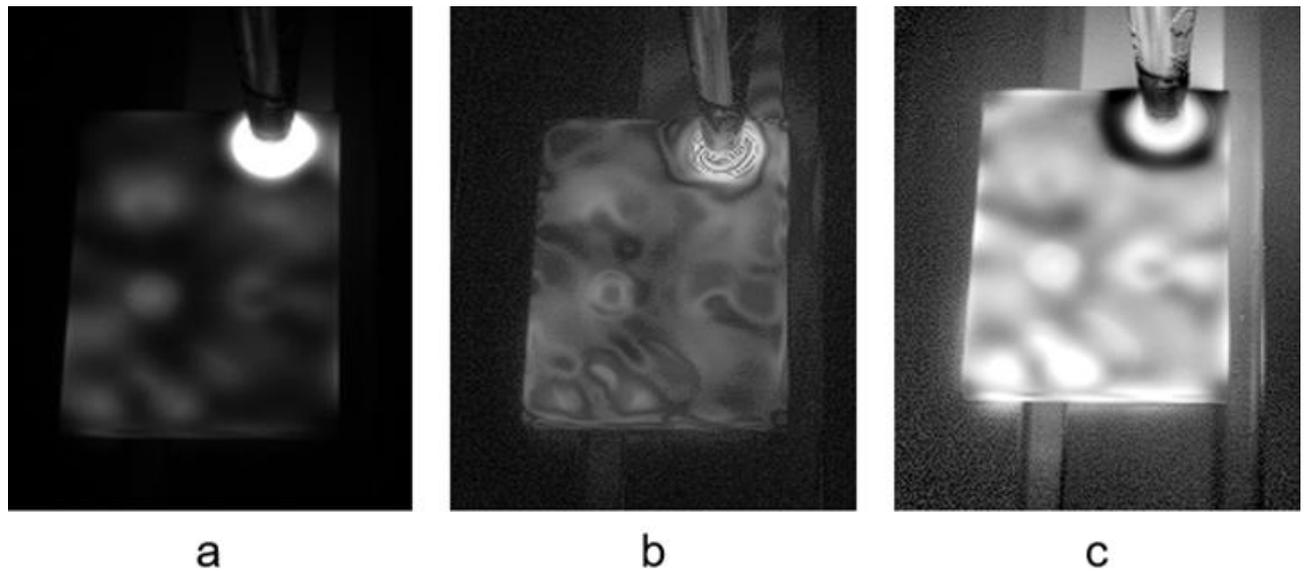
**Fig. 6** Specimen with circular flat bottom holes, frequency 0.02 Hz; a) amplitude image, b) complex image, c) phase image

The output of the measurements included amplitude, phase, and complex images. Figures 5 and 6 display the specimens excited at a frequency of 0.02 Hz, along with a comparison of the acquired data. During the experiment, the position of the sonotrode was altered (located at the top right corner of the specimen and centred at the top) to assess how placement influenced defect detectability.

During the measurements, three types of output images were obtained: amplitude, phase, and complex. The amplitude image represents the magnitude of the thermal response to ultrasonic excitation; however, it is influenced by surface properties such as the emissivity and reflectivity of the surface. The phase image expresses the phase shift between the excitation

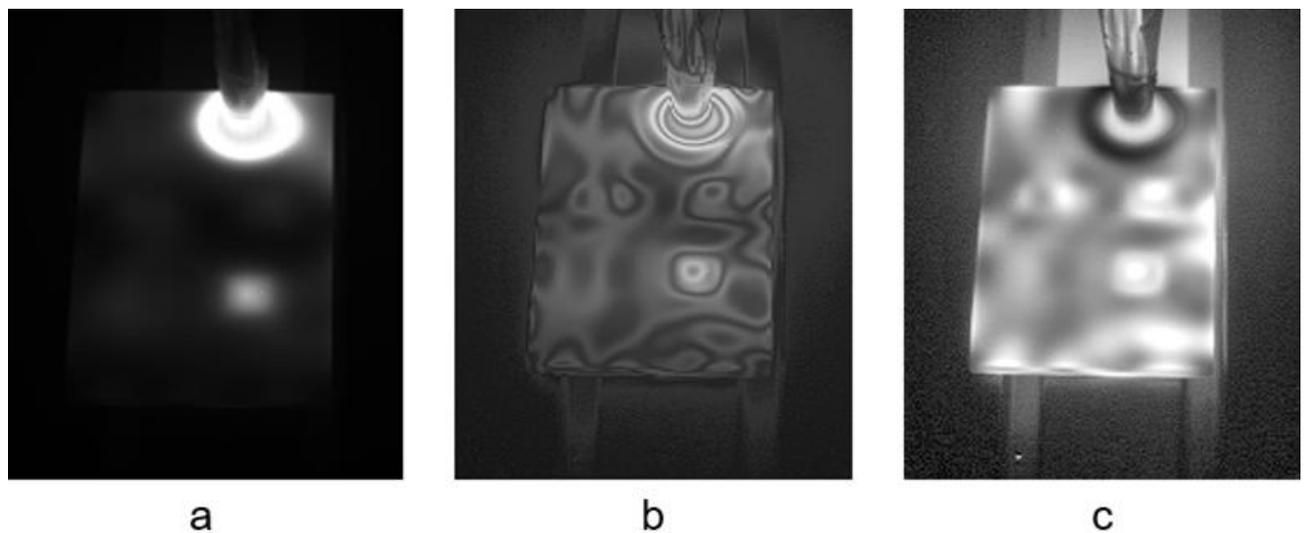
**Fig. 7** Specimen with square flat bottom holes, frequency 0.02 Hz; a) amplitude image, b) complex image, c) phase image

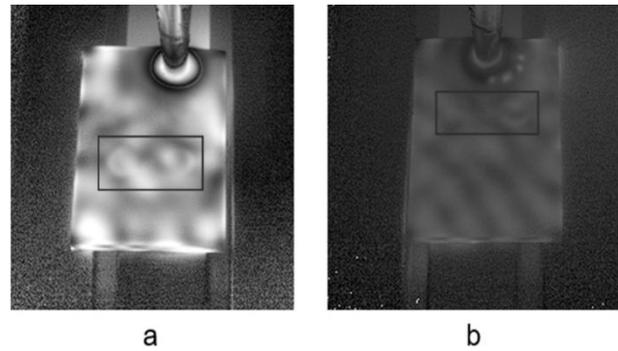
**Fig. 8** Specimen with circular flat bottom holes, frequency 0.04 Hz; a) sonotrode placement at the edge, b) sonotrode placement in the center

The experimental results demonstrated that the placement of the ultrasonic sonotrode had a substantial impact on defect detectability. When the sonotrode was positioned at the edge of the specimen

(Figure 7a), the outlines and circular shapes of two flat-bottom holes (highlighted in the red rectangle) are clearly detectable in a phase image. This visibility can be attributed to the superposition of waves, which occurs as mechanical waves reflect off the specimen boundaries. The resulting interference patterns create more complex and varied deformation gradients within the material, making the thermal anomalies caused by defects more apparent. Conversely, when the sonotrode was placed at the center of the specimen (Figure 7b), only one defect remained distinguishable. This is likely due to the highly symmetric excitation patterns, which limit the

generation of complex wave interference and result in a more uniform energy distribution throughout the material. This more uniform field makes the subtle thermal signatures of defects much more difficult to detect.

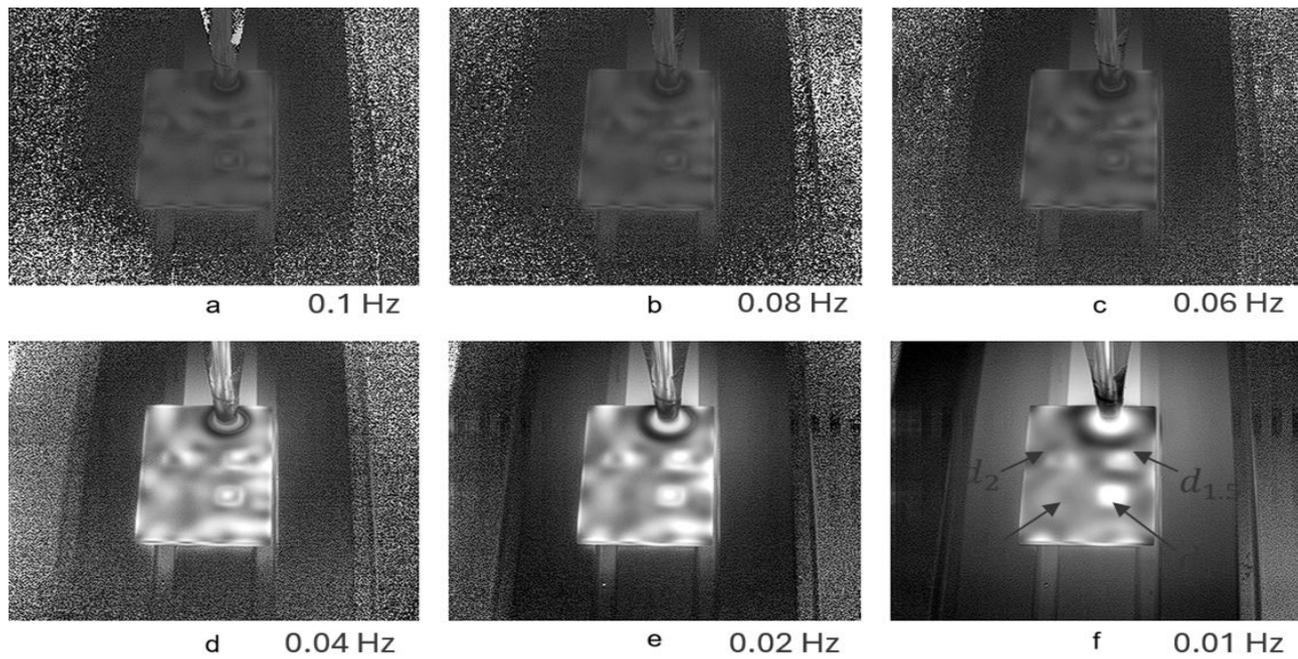
**Fig. 9** Specimen with square flat-bottom holes at various frequency values

In the phase images, defect resolution and detectability were assessed as a function of the applied modulation frequency, which ranged from 0.1 Hz to 0.01 Hz in increments of 0.02 Hz. The results indicate that the defect located nearest to the surface (a 3 mm deep defect situated 1 mm below the surface of the 4 mm thick specimen) was detectable at all frequencies tested, regardless of defect geometry, as can be seen in Figure 8 and Figure 9.

Defects positioned at depths of 1.5 mm and 2 mm beneath the surface were visible only at certain frequencies. Square-shaped defects demonstrated improved visibility compared to circular ones, and a frequency of 0.04 Hz appeared to be the optimal frequency for their detection in this material. Conversely, the deepest defect, located at 3 mm below the surface, remained undetectable at all excitation frequencies examined.

Moreover, a notable difference in detectability was found depending on the geometry of the defects, with square-shaped defects exhibiting greater contrast than

circular ones. This phenomenon can be attributed to the sharp edges and corners of square defects, which create local stress concentrations and, consequently, generate more intense frictional heating at the interface between the defect zone and the intact area of the material.

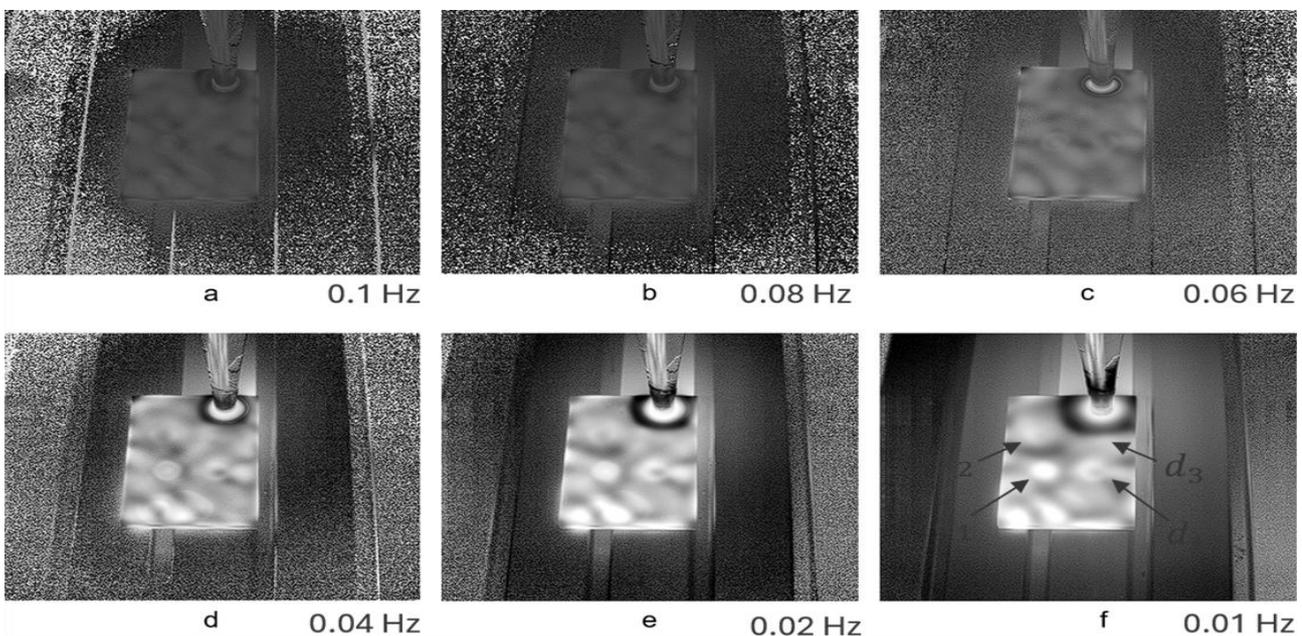
**Fig. 10** Specimen with circular flat-bottom holes at various frequency values

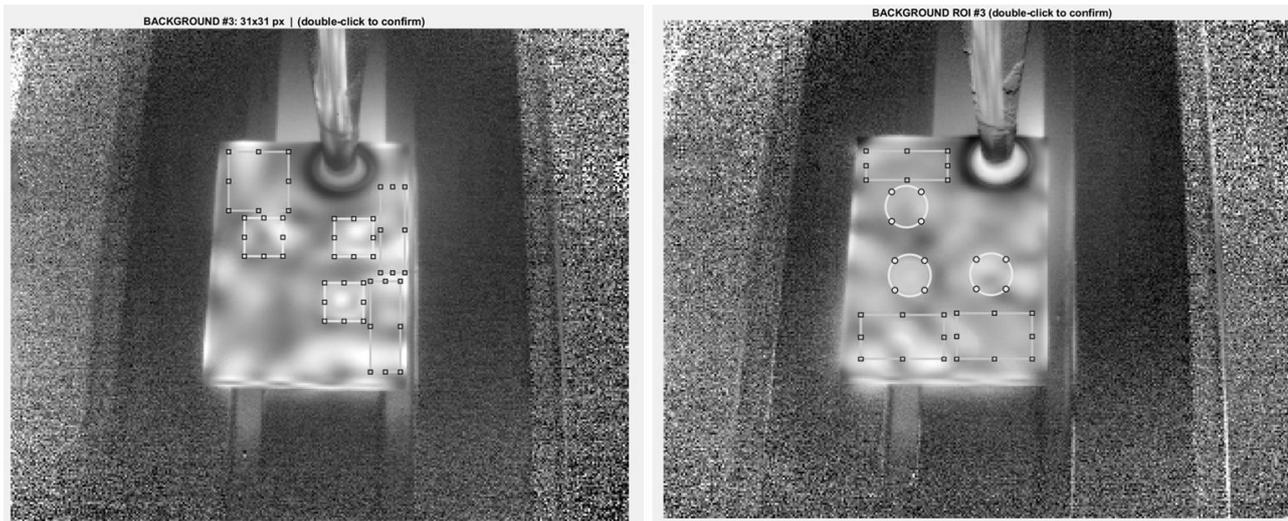
**Fig. 11** Interactive selection of ROIs for the defect zone and for the background for both defect geometries

As the first step, a reference image at 0.04 Hz was selected, since defects appeared most clearly visible at this modulation frequency from a visual inspection perspective. Subsequently, circular or square ROIs were drawn interactively around the defects, together with rectangular background ROIs. During the ROI selection, the software displayed the size of the drawn shapes to ensure consistency across all defects. To achieve a reliable CNR calculation, the area of the background ROI was always maintained at least 1.5 times larger than the defect ROI. The position of the ROIs was then saved as binary masks and propagated across all modulation frequencies, ensuring that the same regions were consistently evaluated. This approach allowed a direct comparison of CNR values as a function of frequency.

To further validate the method, the standard deviation of CNR values was determined by introducing small artificial shifts of the background ROIs ( $\pm 2$  pixels in both x and y directions), while the defect ROI remained fixed. This procedure was repeated for four shifted positions in addition to the original placement, and the standard deviation of the resulting CNR values was calculated. The obtained values are presented as error bars in the graphs, indicating the sensitivity of the results to the choice of background. Larger error bars, therefore, represent frequencies where the background selection has a strong influence on the visibility of the defect, whereas smaller error bars indicate stable and reliable CNR estimates.

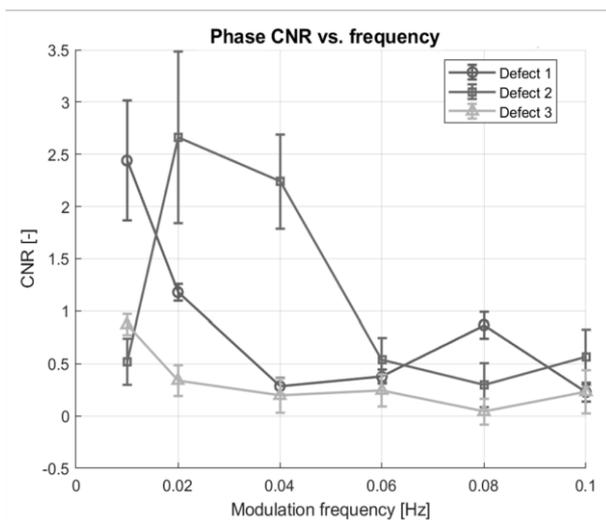
**Fig. 12** CNR values for the specimen with a square-shaped defects

Figure 12 shows the dependence of the CNR on the modulation frequency for square-shaped defects located at different depths below the sample surface.

Defect 1, positioned closest to the surface, exhibited the highest CNR value at 0.01 Hz, indicating the strongest contrast at this frequency. However, at such a low frequency, the effect of thermal diffusion becomes dominant, which causes blurring of the defect edges and reduces the sharpness of its contours. The error bar for this frequency is relatively large, suggesting that the calculated CNR value was strongly influenced by the selection of the background ROI. A secondary peak was observed at 0.08 Hz, which appears to be the most suitable frequency for reliably visualizing defects located at this depth.

Defect 2, located 1.5 mm below the surface, reached its maximum CNR values at 0.02 and 0.04 Hz. At 0.02 Hz, however, the result again showed a strong dependence on the background position (as reflected by the large error bar), while the value at 0.04 Hz can be considered more reliable. Thus, 0.04 Hz was determined to be the optimal frequency for detecting this defect.

Defect 3, situated 2 mm below the surface, was generally poorly detectable at all tested frequencies, with only a slight improvement at 0.01 Hz. This result is in good agreement with visual inspection, where the defect was only weakly visible across the frequency spectrum.

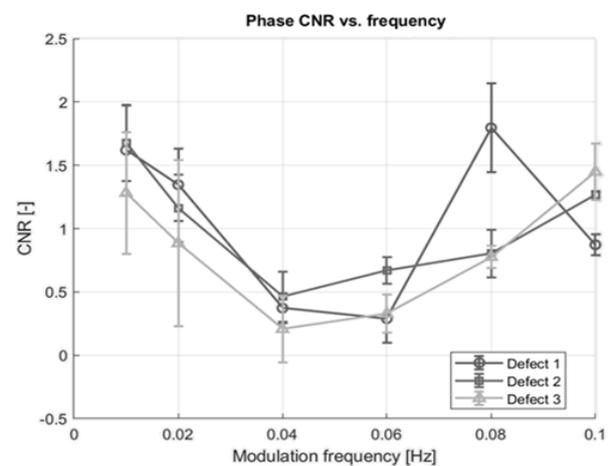
**Fig. 13** CNR values for the specimen with circular-shaped defects

Figure 13 presents the results of the CNR evaluation for circular defects at different depths. In comparison with square-shaped defects, the CNR values did not reach similarly high levels, which indicates that circular defects were generally less detectable due to their geometry.

Defect 1, located closest to the surface (1 mm beneath it), exhibited its maximum CNR value at 0.08 Hz. This observation is consistent with the theoretical relation between modulation frequency and thermal diffusion length (Eq. 5), where higher frequencies are more suitable for near-surface defects. At lower frequencies (0.01 Hz), the contrast was also relatively high, but the edges of the defect became blurred due to thermal diffusion, leading to a less

Defect 2 (located 1.5 mm beneath the surface) and Defect 3 (located 2 mm beneath the surface) both reached their highest CNR values at 0.01 Hz, which corresponds to deeper thermal wave penetration. Nevertheless, the magnitude of these values remained relatively low compared to the square-shaped defects, and the large error bars again suggest that the visibility of circular defects is highly dependent on background selection.
