## Identification of the Cause of Damage to the Firefighter Ladder

Filip Průša<sup>1</sup>, Vít Jonák<sup>1</sup>, Angelina Strakošová<sup>1</sup>, Karel Doubrava<sup>2</sup>, Miroslav Španiel<sup>2</sup>, Václav Vystrčil<sup>3</sup>, Dalibor Vojtěch<sup>1</sup>

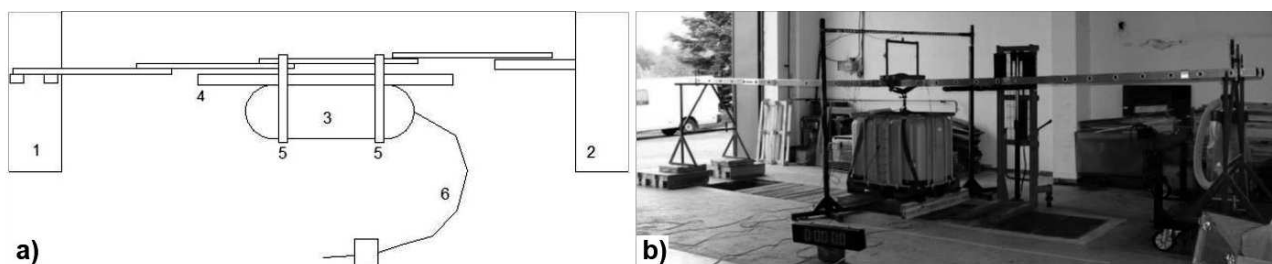
**Fig. 2** Scheme of the testing set-up showing: a) schematic drawing (1,2 – supports; 3 – water bag; 4 – protective pad; 5 – straps; 6 – water inlet with flow meter); b) real set-up used for the testing

The bags were continuously filled with water and the ladder sag was measured at different moments of the test. It was found, that, against the presumptions, both the ladders no. 1 made of much more complex beams could withstand significantly lower load compared to the ladder no. 2. Therefore, the ladder no. 1 were examined for microstructure including optical microscopy (OM, Olympus PME-3) and scanning electron microscopy (SEM, Tescan Vega 3-LMU) equipped with energy dispersive spectroscopy (EDS, Oxford INCA 20 mm<sup>2</sup>) detector used for chemical microanalysis of present phases. The beam profile and profile across the weld zone was also examined for
