Analysis of the Influence of Surface Condition on the Corrosion Behavior of Alloy 2024

Iryna Hren, Sylvia Kusmierczak, Katarína Kurajdová, Milan Luňák

Faculty of Mechanical Engineering, J. E. Purkyne University in Usti nad Labem. Pasteurova 3334/7, 400 01 Usti nad Labem. Czech Republic. E-mail: iryna.hren@ujep.cz, sylvia.kusmierczak@ujep.cz, katarina.kurajdova@ujep.cz, milan.lunak@ujep.cz

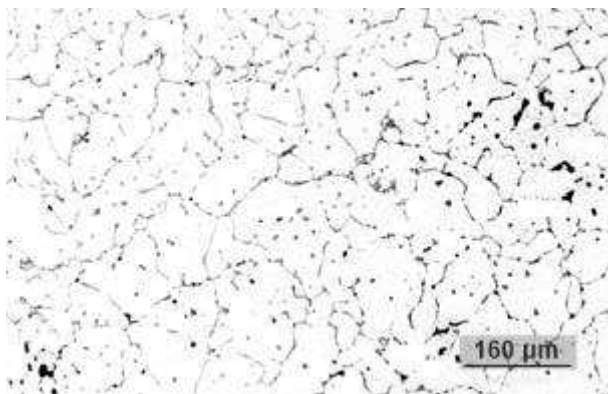
The microstructure of the starting material is shown in Figure 1. As can be seen from the picture, the dendrites have a uniform distribution and comparable size. Also in Figure 1, a locally visible occurrence of interdendritic corrosion, which is typical for this type of Al alloys, can be seen.

Fig. 1 Microstructure of sample 1-1 from alloy 2024, cast condition, mag. 100 \times

The microstructure of sample 2024 consists mainly of the binary eutectic $\alpha + \text{CuAl}_2$ and a small amount of the ternary eutectic $\alpha + \text{CuAl}_2 + \text{Cu}_2\text{Mg}_2\text{Al}_5$. In

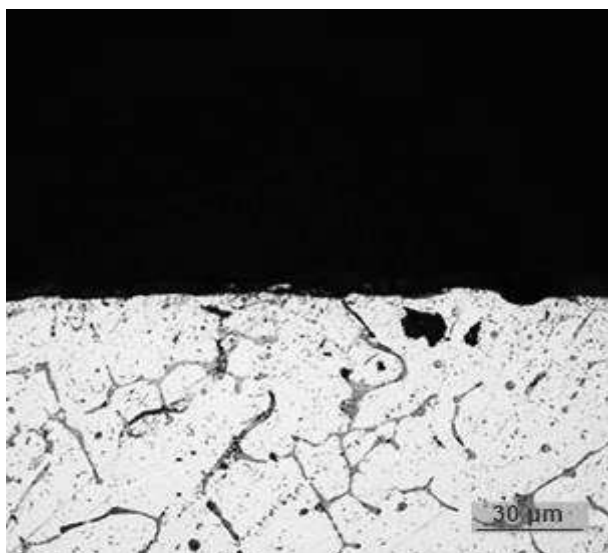
Fig. 2 Microstructure of sample No. 1-1 96 hours of corrosion exposure, mag. 500 ×

the samples were removed, then the samples were cleaned and dried. Metallographic sections of each sample were prepared to evaluate corrosion attack. The samples were evaluated using an Olympus LEXT 5000 light microscope. After 96 hours of exposure in the corrosion chamber (Figure 2), uneven local areas of corrosion attack were visible on the surface, from the microscopic point of view it was pitting corrosion. After longer exposure times, the infestation increased in all directions. For clarity, in Figure 3 to 5 show examples of pitting corrosion in the samples after 168, 240, 480 h. In Figure 3, the interdendritic porosity phase at the grain boundaries and also at the grain boundaries is probably still excluded. The only exception was sample 2-5 and 2-6 (see Figures 6 and 7) after 720 and 1008 h of exposure. In Figure 6 shows the microstructure of uneven distribution of pitting and intergranular corrosion. Intergranular corrosion is closely related to the occurrence of interdendritic intermetallics, and penetrates up to 95 μm below the alloy surface. As can be seen from Figure 6 and 7 intergranular corrosion propagates along the grain boundaries, which are formed by Al_2Cu .

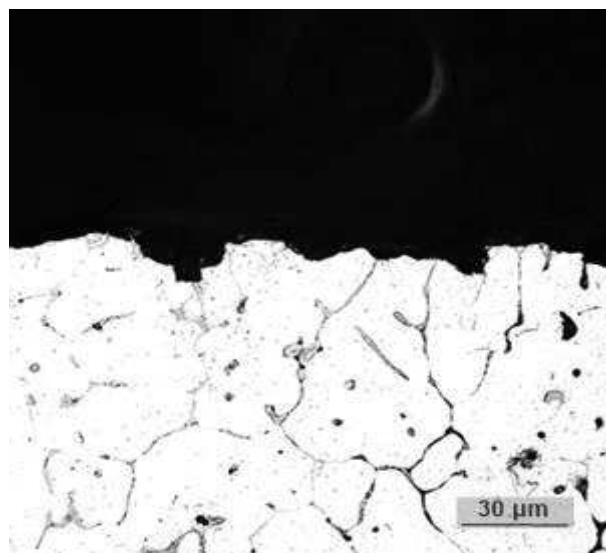
Fig. 5 Microstructure of sample No. 1-4 with pitting corrosion after 480 hours, mag. 500 ×

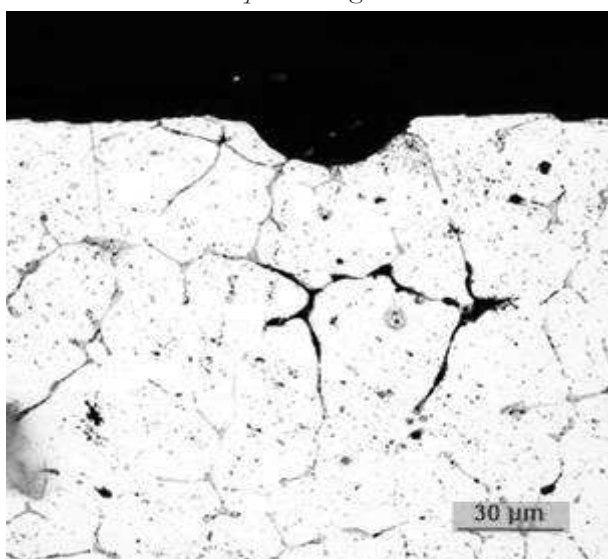
Fig. 3 Microstructure of sample No. 1-2, pitting corrosion, 168 hours exposure, mag. 500 ×

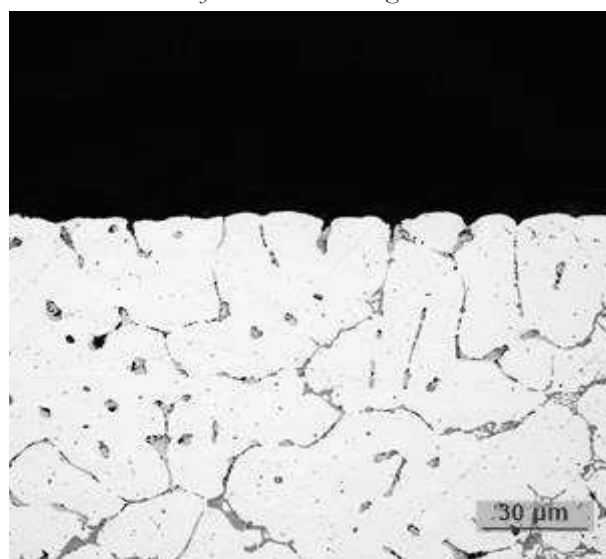
Fig. 6 Microstructure of samples No. 1-5 with pitting corrosion after 720 hours, mag. 500 ×

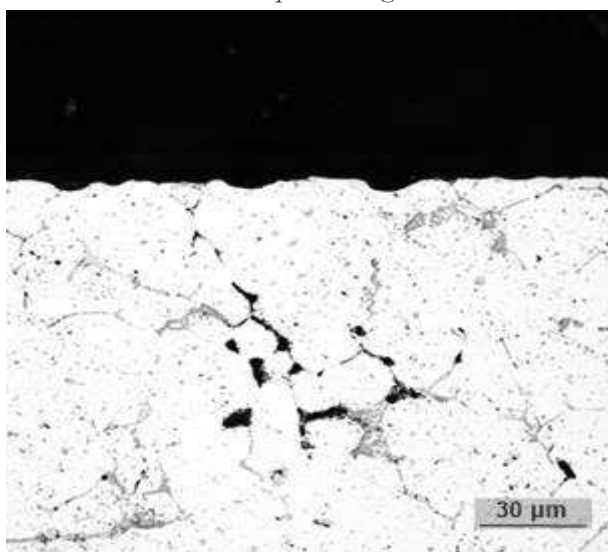
Fig. 4 Microstructure of sample No. 1-3 with uneven pitting corrosion after 240 hours, mag. 500 ×

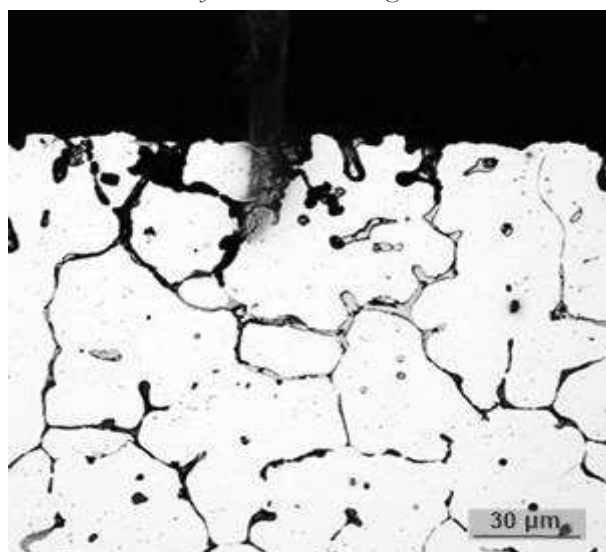
Fig. 7 Microstructure of sample No. 1-6 with intercrystalline corrosion after 1008 hours, mag. 500 ×

Based on these evaluations, it was found that the character of surface attack is in all samples of alloy 2024, except for sample No. 1-6 (Figure 7) after 1008 h of exposure in the corrosion chamber.

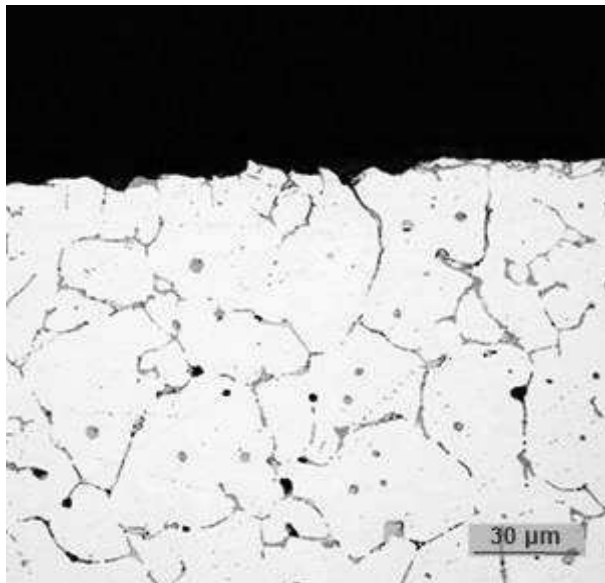
Fig. 8 Microstructure of samples 2-1 with uneven pitting corrosion after 96 hours, mag. 500 ×

In the next part of the experiments, the corrosion degradation of the samples after their machining was evaluated. In Figures 8 to 10, as with unmachined samples, an uneven pitting distribution can be seen. Pitting corrosion occurs in dendritic nuclei [12], because Cu is depleted by microsegregation processes in these areas. Dendritic nuclei thus become more active than the rest of the dendrites, which is reflected in a change in chemical composition and subsequent change in the electrode potential and thus a change in resistance to the corrosive environment, as confirmed by research [16-18].

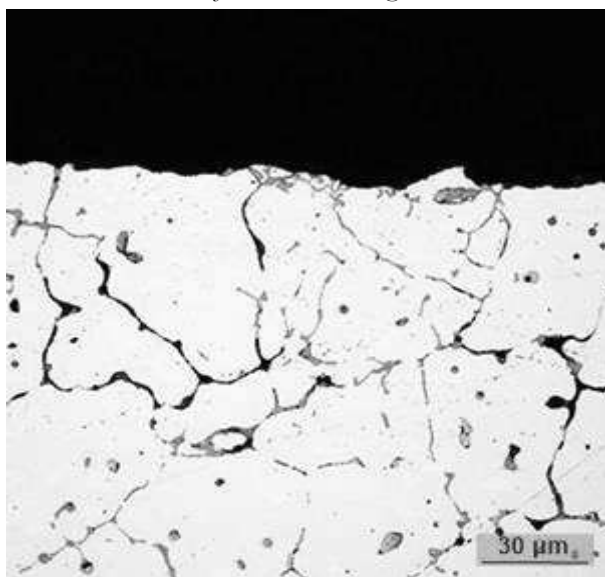
Fig. 9 Microstructure of sample 2-2 with non-uniform pitting corrosion and intermetallic phase of AlCuFeMn type in the form of Chinese script after 168 hours, mag. 500 ×

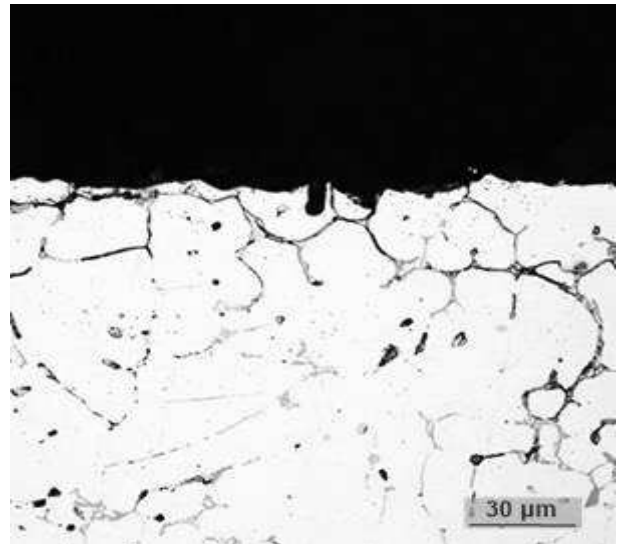
Fig. 10 Microstructure of sample 2-3 with significant pitting corrosion after 240 hours, mag. 500 ×

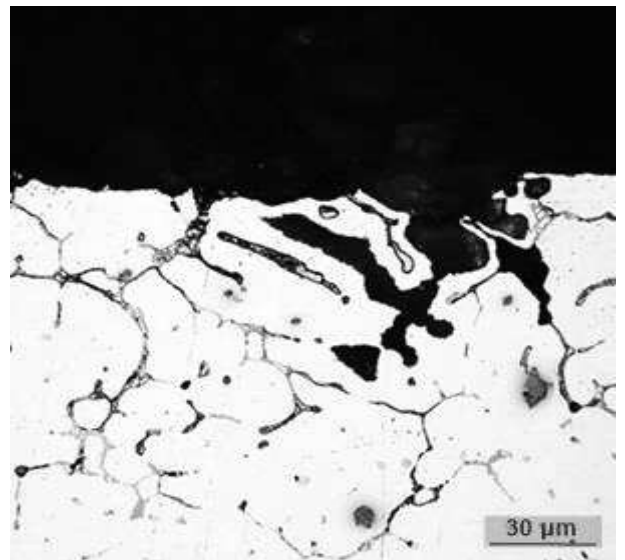
Fig. 11 Microstructure of samples 2-4 with intergranular corrosion after 480 hours, mag. 500 ×

Sample No. 2-4 to 2-6 (Figures 11 to 13) showed high-intensity intercrystalline corrosion. As can be seen from Figure 11 and 12, corrosion begins to act at grain boundaries that are rich in Al_2Cu and continues in areas of the α -phase that is depleted of Cu. The corrosion of the α -phase can be explained by the galvanic connection between Al_2Cu and the α -phase, because Al_2Cu is cathodic with respect to the α -phase [18]. Figure 13 clearly shows that the corrosion is located in two areas. The first is the α -phase adjacent to the interdendritic regions, consisting mainly of Al_2Cu , and the second are the dendritic nuclei, corroded by the mechanism described above.

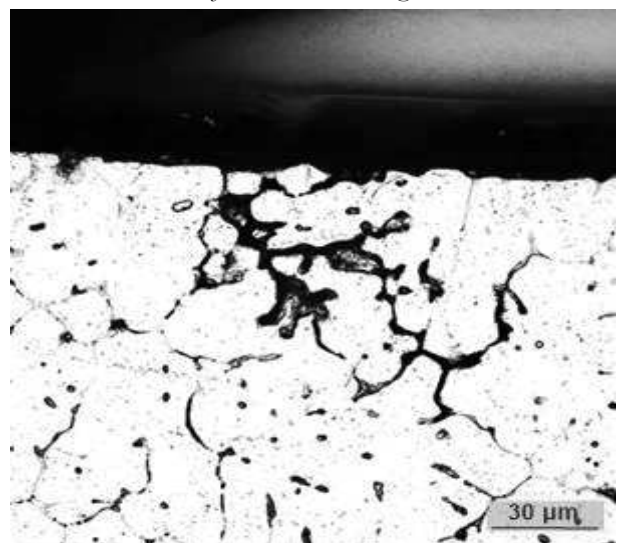
Fig. 12 Microstructure of sample 2-5 with corrosion along grain boundaries after 720 hours, mag. 500 ×

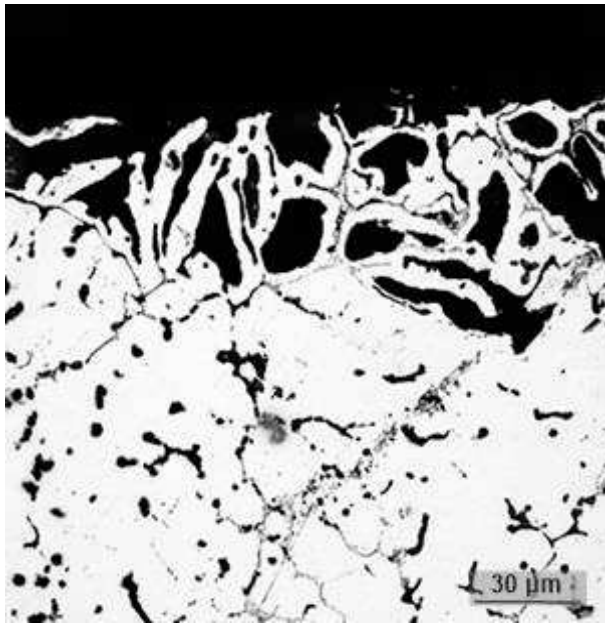
Fig. 13 Microstructure of sample 2-6 from intercrystalline corrosion after 1008 hours of corrosion exposure, mag. 500 ×

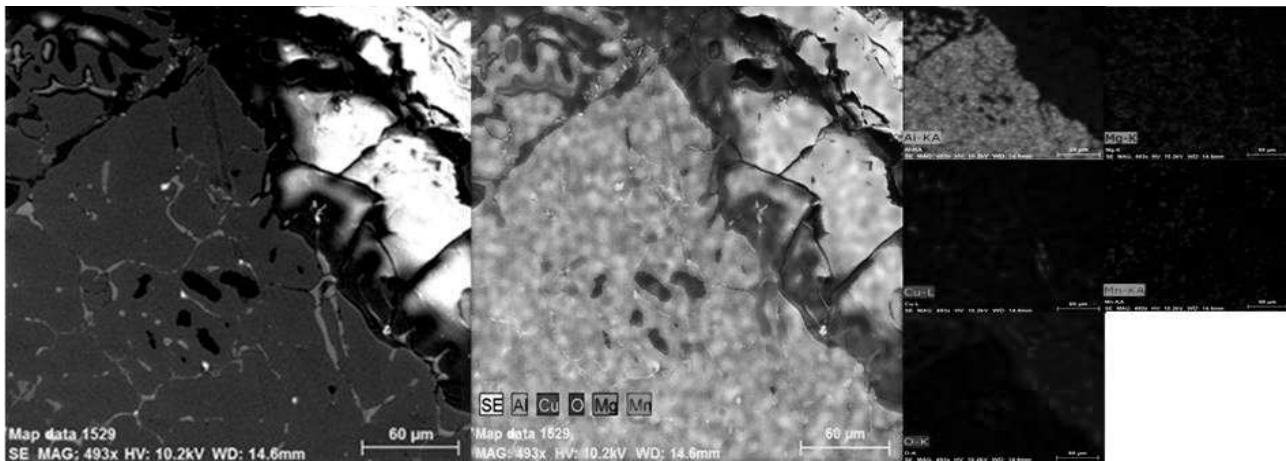
Fig. 14 Microstructure of sample No. 1-3, elemental cross-sectional maps of the sample in alloy 2024

Figure 14 and 15 show the areas of corrosion attack and the subsequent mapping of these areas. It can be seen from Figure 14 that in this area corrosion products have penetrated into the α -matrix that surrounds them. An increased distribution of O was observed. This confirms the recording of the area EDS analysis and the quantification of the results of the area EDS analysis in both areas (Figure 15 and 17), where the oxygen content up to about 52% wt. was captured.

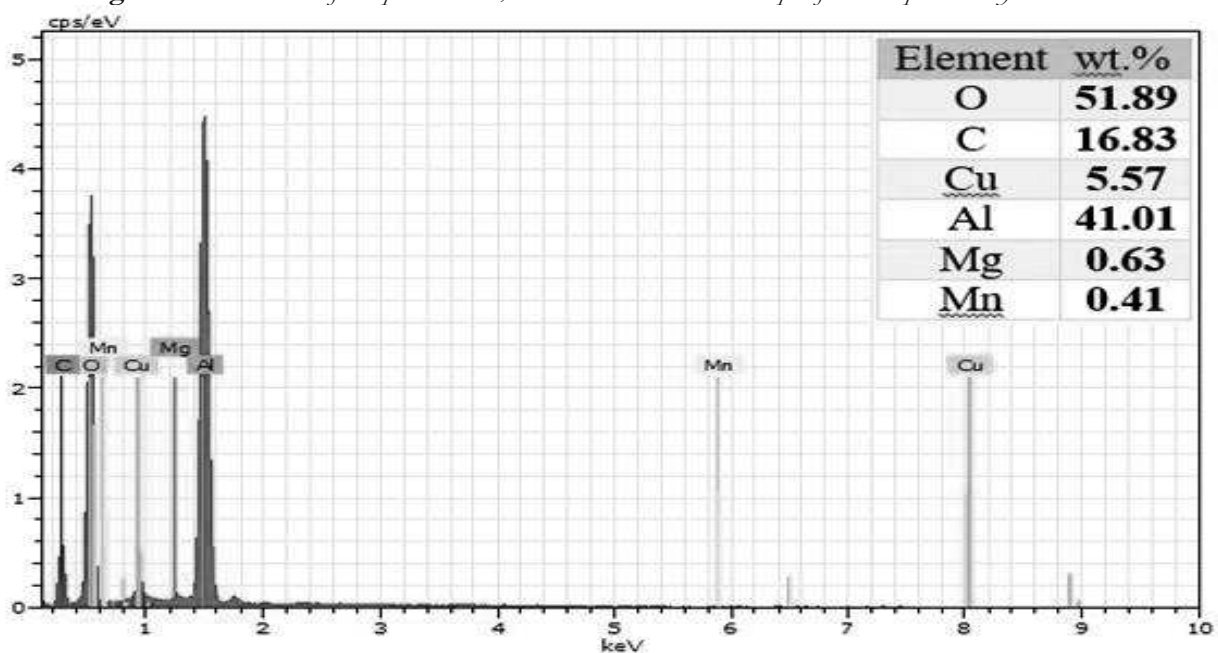
Fig. 15 Spectrum of analyzed chemical elements from samples 1-3 and quantification of the results of area EDS analysis

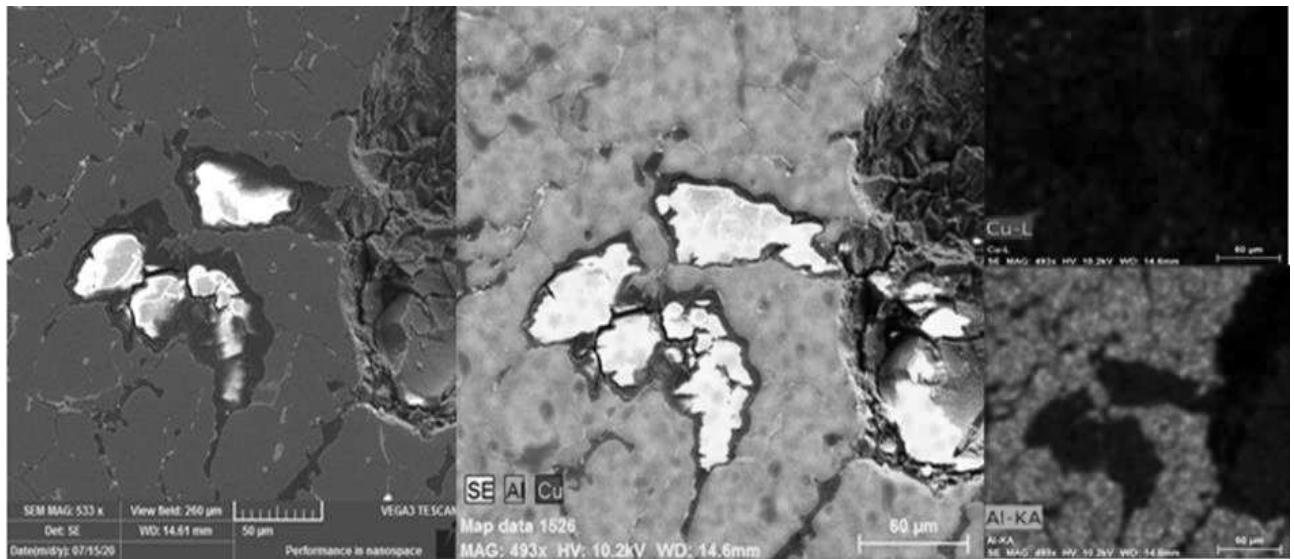
Fig. 16 Microstructure of Sample No. 2-1 and elemental maps of atoms on the surface of alloy 2024

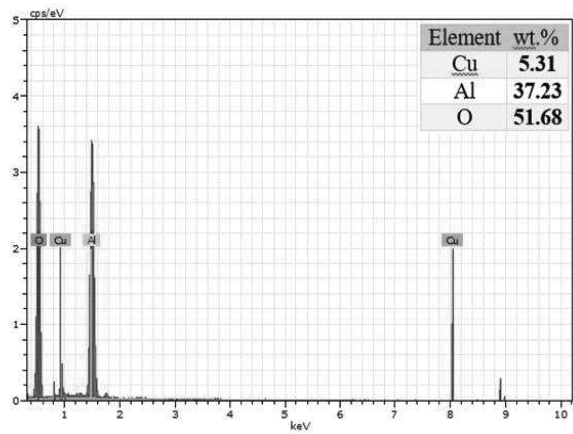
Fig. 17 Spectrum of analyzed chemical elements of samples No. 2-1 and quantification of the results of the area EDS analysis

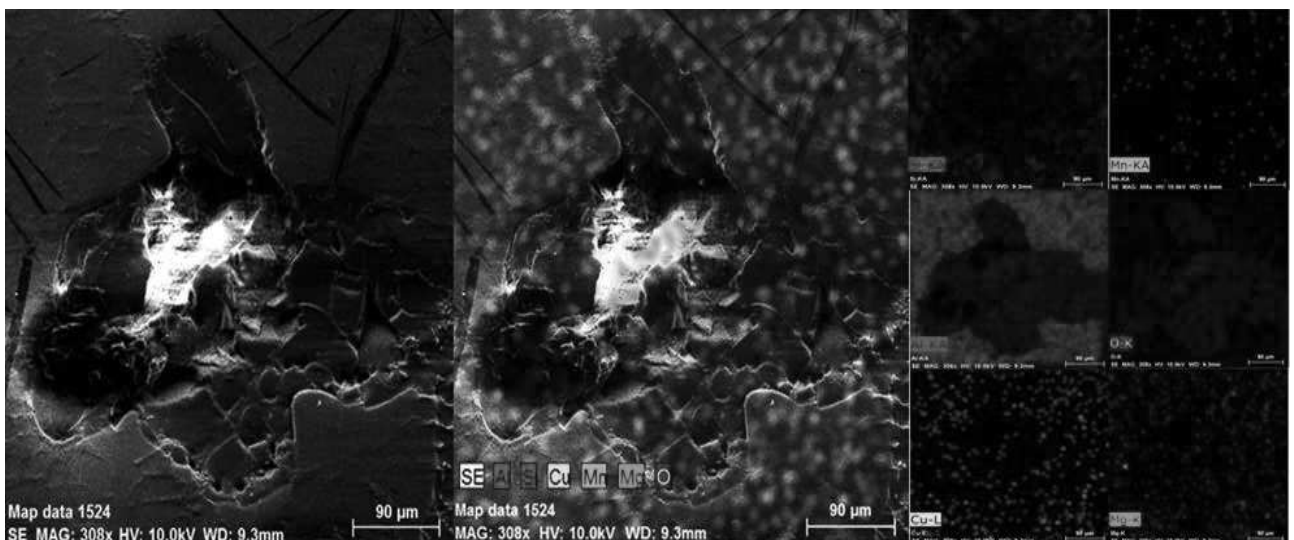
Fig. 18 Microstructure of the sample No. 2-5 and element maps of atoms on the surface of the alloy 2024

In another area of corrosion, EDS analysis of the element map of atoms on the surface of alloy 2024 was also performed (Figure 18). The presence of intergranular corrosion has also been documented in this area. In the area of corrosion propagation, a Cu-rich region can be seen, it can be assumed that these are intermetallic phases of Al_2Cu .

From Figure 18 it can be seen that O was uniformly distributed throughout the area, which is confirmed by the recording of the area EDS analysis and the quantification of the results of the area EDS analysis in Figure 19.

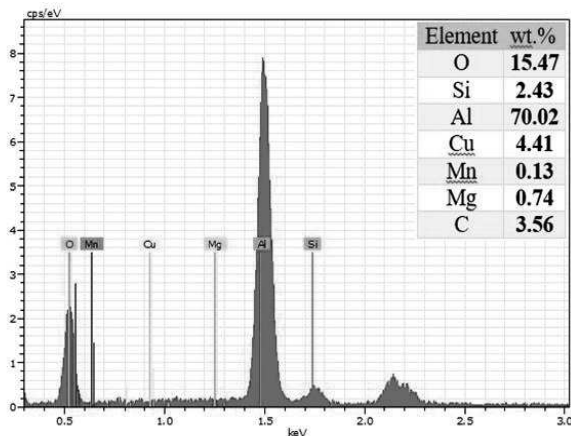
Fig. 19 Spectrum of analyzed chemical elements from samples No. 2-5 and quantification of the results of its area EDS analysis
